ELECTRICAL SAFETY AUDIT REPORT

(Post Implementation)

**AMALA INSTITUTE OF MEDICAL
SCIENCES**

July 2025

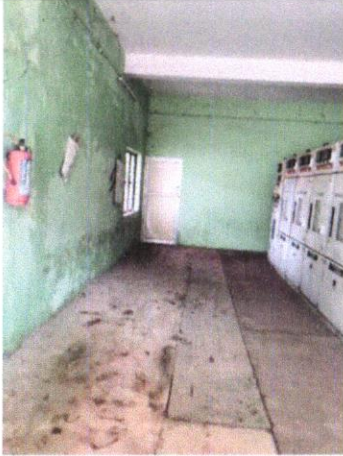
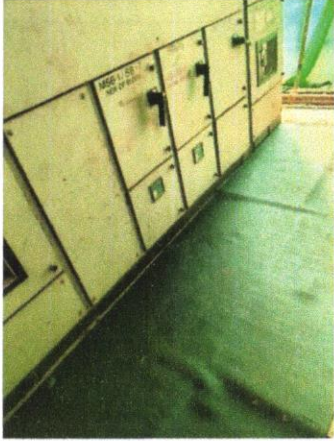
Sl no	Observation	Location/Photo	Implementation status	
1	Medium	HT Panel room/LT Panel rooms		
	The electrical safety mats are in a dilapidated condition, and appropriate PPE such as gloves are provided in the room

Implemented on 10/07/25

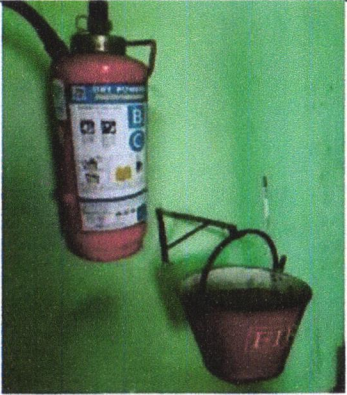
2	Low	LT Panel room – Chavara Block		
	Unwanted materials are stored in fire sand buckets

Implemented on 15/07/25
3	High	LT Panel room – Chavara Block		
	A couple of overheated panels are left open, with pedestal fans provided to cool them

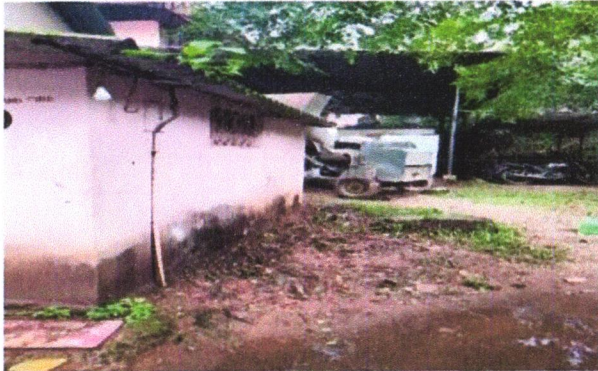
Implementation details				
4	Medium	Various locations		
	<p>The earth pits near the Chavara LT panel room are covered with debris. All other earth pits, including the aforementioned, are not properly marked</p>

<p>Earth pit is marked properly</p>	<p>Implemented on 18/07/25 08/06/25</p>
5	High	Chavara Block -Ground floor		
	<p>Electrical safety mats are not deployed in front of the panels, and a section of the cable trench is left open, which may pose various hazards</p>

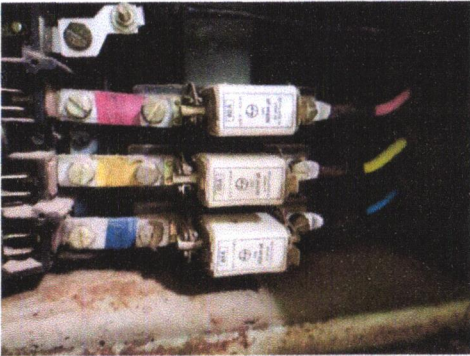
<p>Electrical safety measures have been implemented, and the cable trenches have been closed.</p>	
6	Medium	Various locations	
<p>The electrical panels were found to be dusty, which may lead to potential issues such as overheating, reduced efficiency, and increased risk of short circuits</p>

<p>Regular cleaning imposed</p> <p>Implemented and continuing now from 02/07/2025</p>

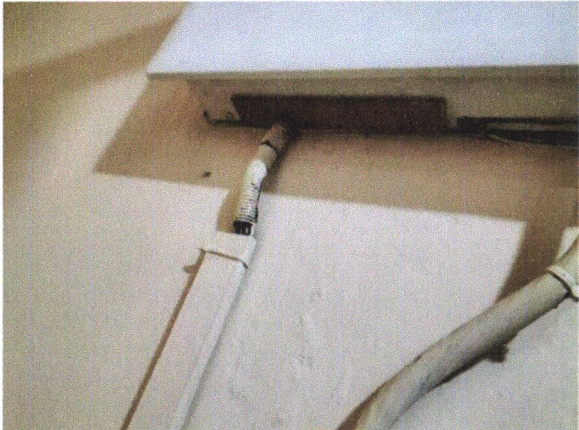
7	Low	Various locations		
	<p>Knockout holes/openings were observed in multiple distribution boards, which may lead to dust ingress and insect entry, potentially causing issues</p>

Knock out holes sealed	<p>Implemented on 03/07/2025</p>
8	Medium	Blood bank – Infection serology		
	<p>In the infection serology room, one AC unit is running continuously at a low set temperature of 19°C, while the other AC unit is not functioning. This may cause the condenser unit to overheat, increasing the risk of fire or equipment failure</p>

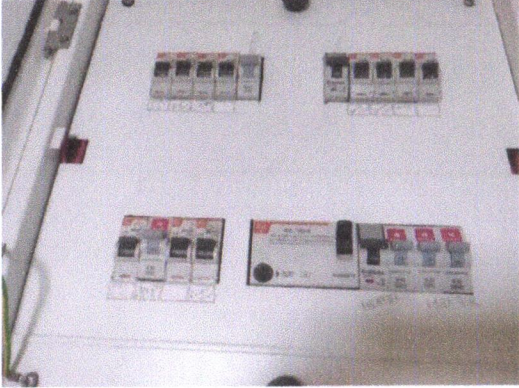
Implementation details				
8	High	Multiple locations		
	100 mA RCCBs are installed in most distribution boards, which may not provide adequate protection against electric shock. Some distribution boards, such as Ward 22 DB and SSB 3C LDB, do not have RCCBs installed, and some existing RCCBs are not functional (Refer RCCB testing section)

Installed 30mA RCCB in the DBs	14/06/25
9	Medium			
	Cable joints were observed in multiple distribution boards, which may pose potential hazards such as overheating, arcing, and electrical faults (Image location: Wall DB - Ward 18)	The cables are removed from the system	Implemented on 12/7/2025

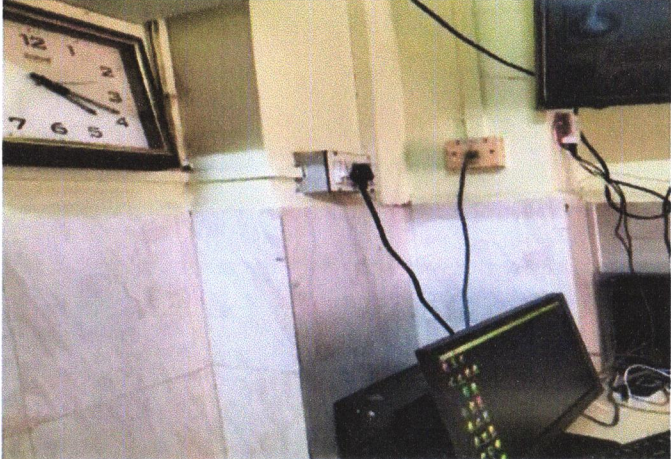
10	<p>Medium</p> <p>Multiple equipment are connected using multi plugs and extension boards, which is not a safe practice (Image : Ward 12 nursing station)</p>	<p>Various locations</p>

<p>Extension boxes are removed from the system and proper methods are followed up.</p>	<p>Implemented on 18/6/2025</p>
11	<p>Low</p> <p>Manual call points, fire hose reels, hydrant points, and fire extinguishers are not marked as per standard guidelines</p>	<p>Multiple locations</p>

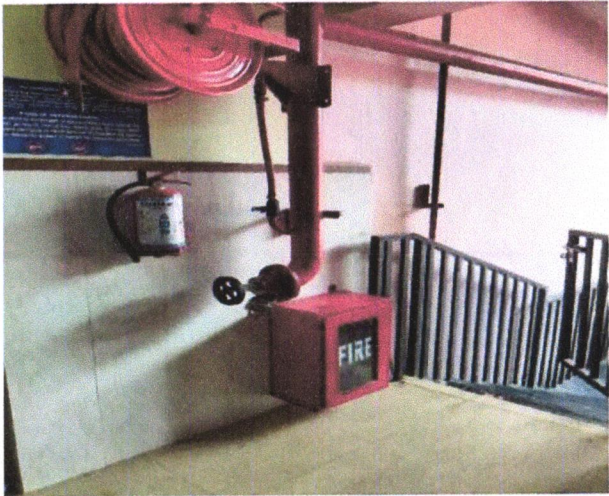
12	High	Multiple locations – Fire exits adjacent to nurising stations		
	<p>Fire exits near the nursing stations at Chavara block are not marked, with one exit found locked. Multiple obstructions were observed at this and other exits, potentially hindering evacuation</p>

<p>Ensure that all fire exits are clearly marked as per NBC Part 4 – Fire and Life Safety, kept unlocked during occupancy, and kept free from obstructions to maintain clear evacuation paths</p>	<p>Implemented on 15/7/2025</p>
13	Medium	Chavara block – Ground floor		
	<p>One of the fire alarm panels was found to be silenced due to a faulty alarm trigger</p>

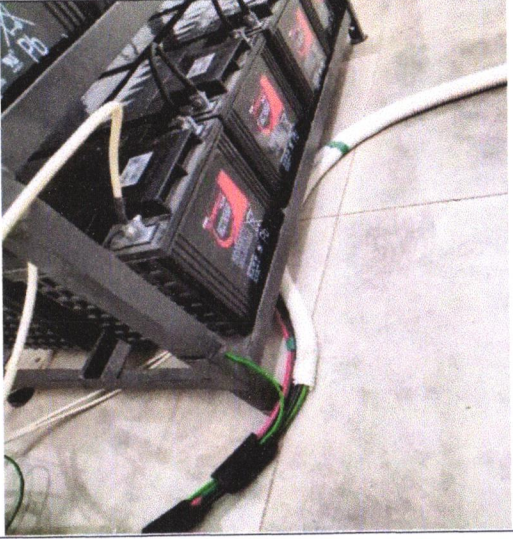
<p>The battery racks are not earthed, posing a potential electrical hazard</p>

<p>Proper earthing done in battery system.</p>	<p>Implemented on 24/06/25</p>
--	--	--	--	--------------------------------

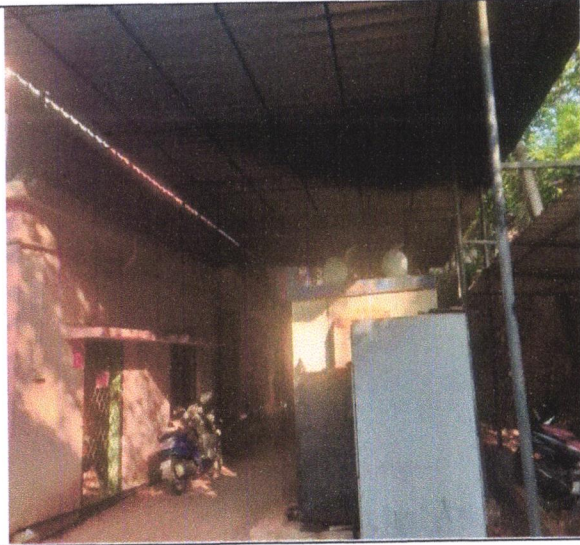
14	<p>Low</p>	<p>Generator area</p>		
	<p>The generator exhaust height is not as per the prescribed standards, potentially causing safety and environmental concerns</p>

<p>Adjusted the height</p>	<p>On 14/7/2025</p>
