Electrical Safety Audit
Report

ELECTRICAL SAFETY AUDIT REPORT

(Post Implementation)

**AMALA INSTITUTE OF MEDICAL
SCIENCES**

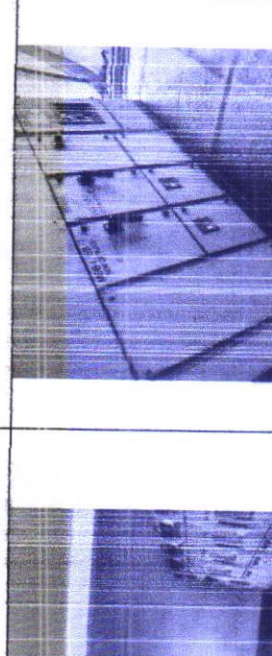
SI no	Observation	Location/Photo	Implementation status
1	<p>Medium</p> <p>The electrical safety mats are in a dilapidated condition, and appropriate PPE such as gloves are provided in the room</p>	<p>HT Panel room/LT Panel rooms</p>

<p>Implemented on 10/07/25</p>

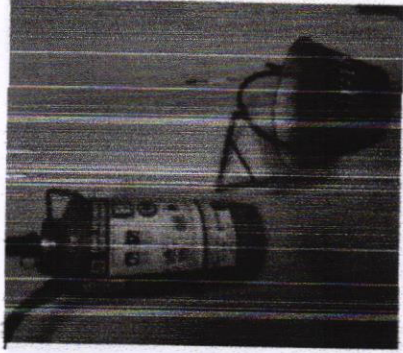
2	<p>Low</p> <p>Unwanted materials are stored in fire sand buckets</p>	<p>LT Panel room - Chavara Block</p>

<p>Implemented on 15/07/25</p>
3	<p>High</p> <p>A couple of overheated panels are left open, with pedestal fans provided to cool them</p>	<p>LT Panel room - Chavara Block</p>

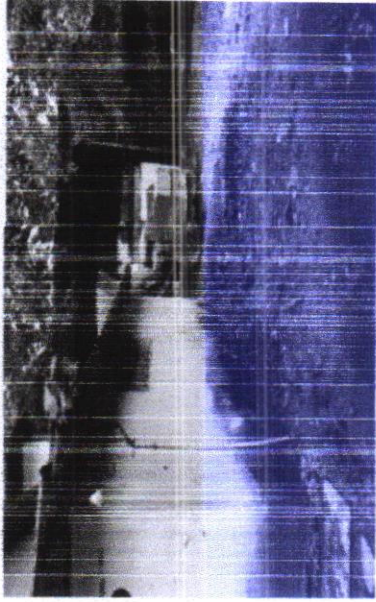
Implementation details		
	Various locations	
4	<p>Medium</p> <p>The earth pits near the Chavara LT panel room are covered with debris. All other earth pits, including the aforementioned, are not properly marked</p>

<p>Earth pit is marked properly</p> <p>Implemented on 18/07/25 08/06/25</p>
5	<p>High</p> <p>Electrical safety mats are not deployed in front of the panels, and a section of the cable trench is left open, which may pose various hazards</p>

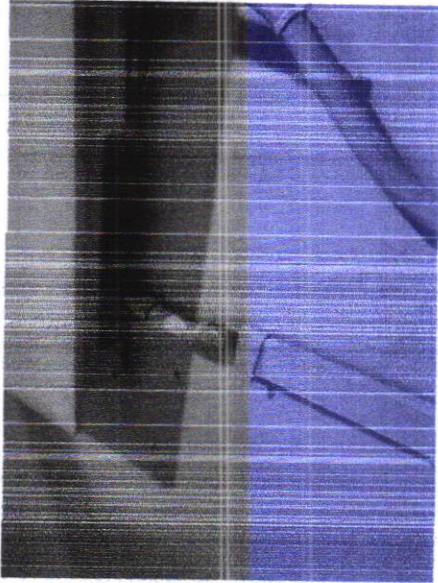
7	<p>Low</p> <p>Knockout holes/openings were observed in multiple distribution boards, which may lead to dust ingress and insect entry, potentially causing issues</p>	<p>Various locations</p>

<p>Knock out holes sealed</p>	<p>Implemented on 03/07/2025</p>
8	<p>Medium</p> <p>In the infection serology room, one AC unit is running continuously at a low set temperature of 19°C, while the other AC unit is not functioning. This may cause the condenser unit to overheat, increasing the risk of fire or equipment failure</p>	<p>Blood bank - Infection serology</p>

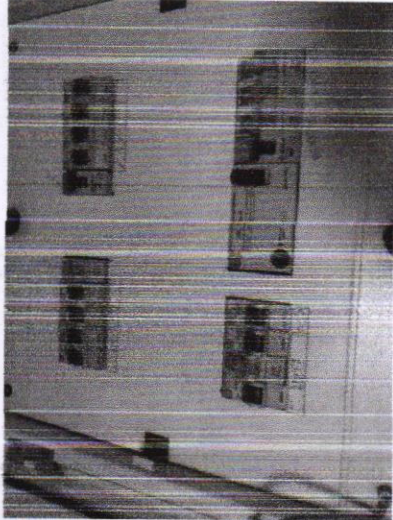
Implementation details			
8	<p>High</p> <p>100 mA RCCBs are installed in most distribution boards, which may not provide adequate protection against electric shock. Some distribution boards, such as Ward 22 DB and SSB 3C LDB, do not have RCCBs installed, and some existing RCCBs are not functional (Refer RCCB testing section)</p>	<p>Multiple locations</p>

<p>Installed 30mA RCCB in the DBs</p> <p>14/06/25</p>
9	<p>Medium</p> <p>Cable joints were observed in multiple distribution boards, which may pose potential hazards such as overheating, arcing, and electrical faults (Image location: Wall DB - Ward 18)</p>	<p>The cables are removed from the system</p>	<p>Implemented on 12/7/2025</p>
10

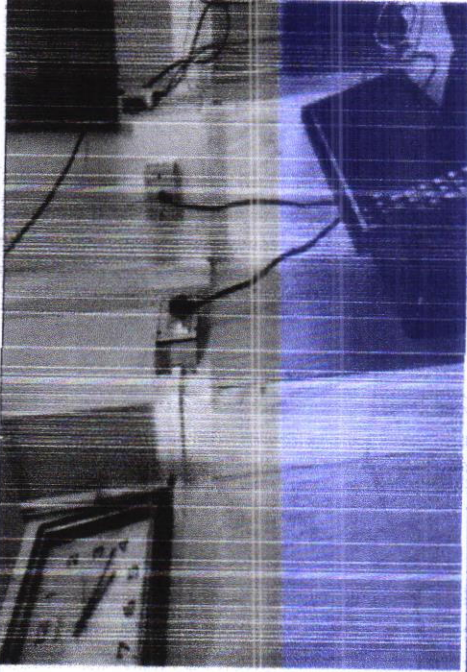
10	<p>Medium</p> <p>Multiple equipment are connected using multi plugs and extension boards, which is not a safe practice (Image : Ward 12 nursing station)</p>	<p>Various locations</p>

<p>Extension boxes are removed from the system and proper methods are followed up.</p>	<p>Implemented on 18/6/2025</p>
11	<p>Low</p> <p>Manual call points, fire hose reels, hydrant points, and fire extinguishers are not marked as per standard guidelines</p>	<p>Multiple locations</p>

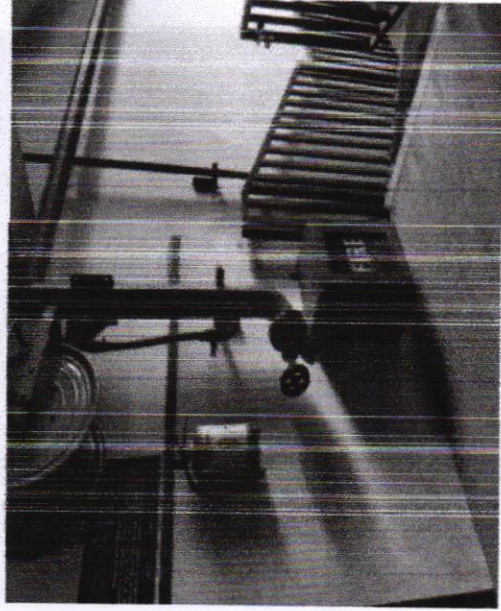
<p>12</p>	<p>High</p> <p>Fire exits near the nursing stations at Chavara block are not marked, with one exit found locked. Multiple obstructions were observed at this and other exits, potentially hindering evacuation</p>	<p>Multiple locations - Fire exits adjacent to nursing stations</p>

<p>Ensure that all fire exits are clearly marked as per NBC Part 4 - Fire and Life Safety, kept unlocked during occupancy, and kept free from obstructions to maintain clear evacuation paths</p>	<p>Implemented on 15/7/2025</p>
<p>13</p>	<p>Medium</p> <p>One of the fire alarm panels was found to be silenced due to a faulty alarm trigger</p>	<p>Chavara block - Ground floor</p>

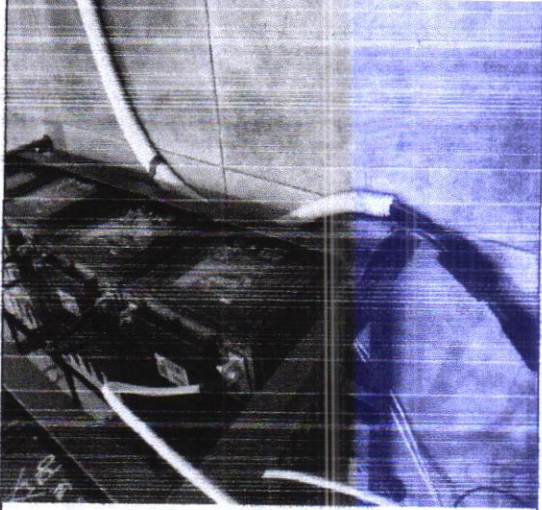
<p>The battery racks are not earthed, posing a potential electrical hazard</p>

<p>Proper earthing done in battery system.</p>	<p>Implemented on 24/06/25</p>
--	--	--	--------------------------------

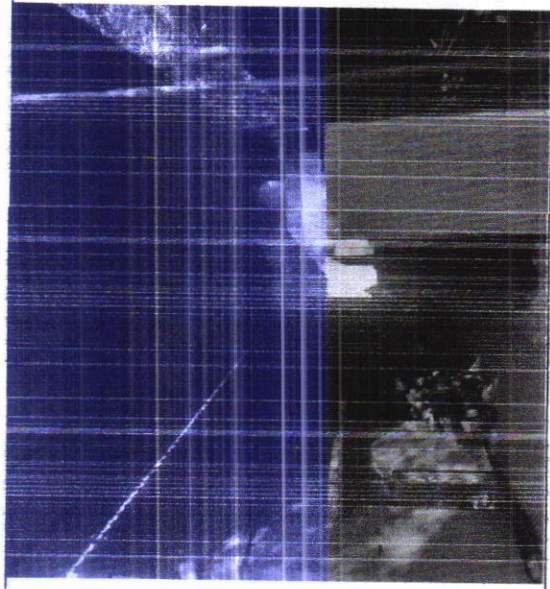
<p>14</p>	<p>Low</p> <p>The generator exhaust height is not as per the prescribed standards, potentially causing safety and environmental concerns</p>	<p>Generator area</p>

<p>Adjusted the height</p>	<p>On 14/7/2025</p>
-----------	---	---	----------------------------	---------------------

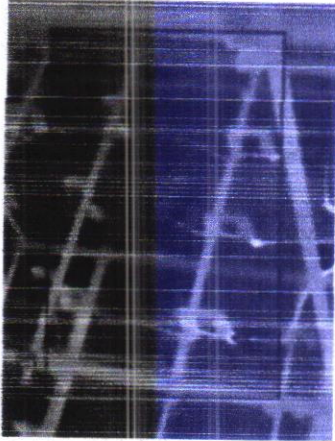
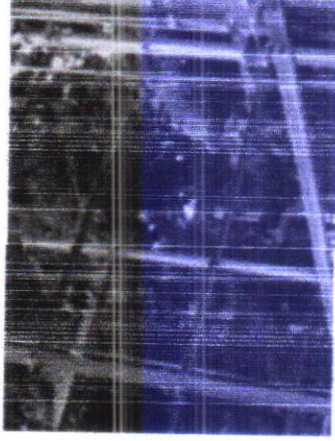
2. Location: DO fuse outgoing		Inference & suggestion	Compliance status

<p>Measurements</p> <table border="1"> <tr> <td>Bx1</td> <td>Max</td> <td>46.0</td> <td>°C</td> </tr> </table> <p>Parameters</p> <table border="1"> <tr> <td>Emissivity</td> <td>0.98</td> </tr> <tr> <td>Ref. temp.</td> <td>40 °C</td> </tr> </table>	Bx1	Max	46.0	°C	Emissivity	0.98	Ref. temp.	40 °C		<p>Rectification done in the cabling.</p>	<p>On29/06/25</p>
Bx1	Max	46.0	°C								
Emissivity	0.98										
Ref. temp.	40 °C

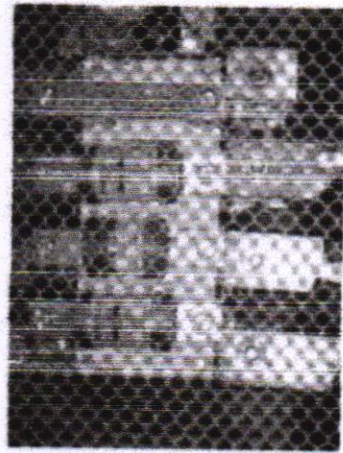
3. Location: MSB - 1/SB3	Inference & suggestion	Compliance status

<p>Measurements</p> <table border="1"> <tr> <td>Bx1</td> <td>Max</td> <td>51.0</td> <td>°C</td> </tr> </table> <p>Parameters</p> <table border="1"> <tr> <td>Emissivity</td> <td>0.98</td> </tr> <tr> <td>Ref. temp.</td> <td>40 °C</td> </tr> </table>	Bx1	Max	51.0	°C	Emissivity	0.98	Ref. temp.	40 °C	<p>Proper bolting done in the panels and reduction in the temperature observed.</p>	<p>Implemented on 28/06/25</p>
Bx1	Max	51.0	°C							
Emissivity	0.98									
Ref. temp.	40 °C

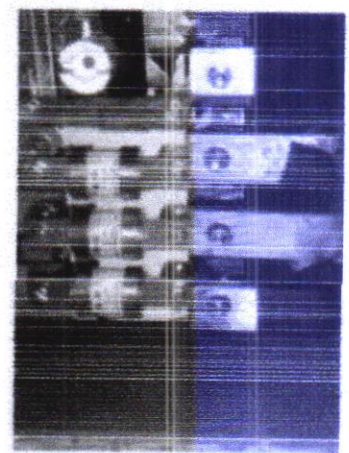
4. Location: MSB 1/SB 2 Main block	Inference & suggestion	Compliance status

<table border="1" data-bbox="750 1360 941 1905"> <thead> <tr> <th>Measurements</th> <th>Value</th> <th>Unit</th> </tr> </thead> <tbody> <tr> <td>Bx1</td> <td>48</td> <td>°C</td> </tr> </tbody> </table> <table border="1" data-bbox="829 1360 941 1905"> <thead> <tr> <th>Parameters</th> <th>Value</th> </tr> </thead> <tbody> <tr> <td>Emissivity</td> <td>0.98</td> </tr> <tr> <td>Ref. temp.</td> <td>40 °C</td> </tr> </tbody> </table>	Measurements	Value	Unit	Bx1	48	°C	Parameters	Value	Emissivity	0.98	Ref. temp.	40 °C	<p>Tightening of joints are done and heat level reduced</p>	<p>29/06/25</p>
Measurements	Value	Unit												
Bx1	48	°C												
Parameters	Value													
Emissivity	0.98													
Ref. temp.	40 °C

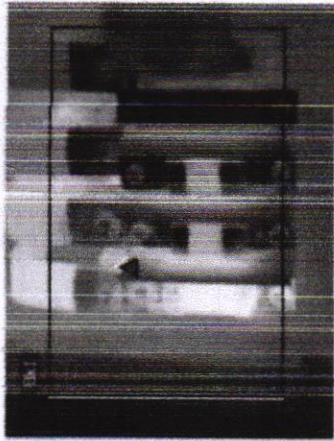
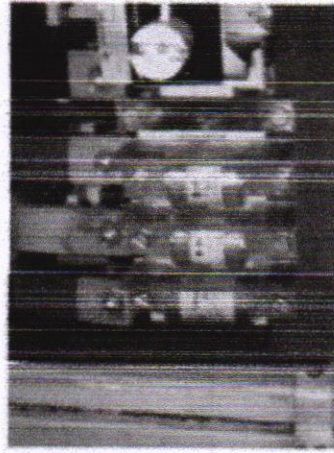
5. Location: MSB 1/SH 1 Research block

Measurements
Bx1 Max 43.3 °C

Compliance status	Inference & suggestion	
Implemented on 17/7/2025	All bolting's are properly tightened, the fuse is securely fixed,

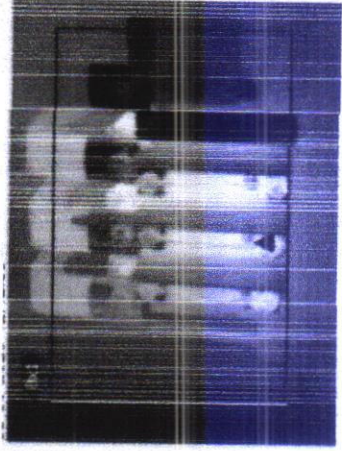
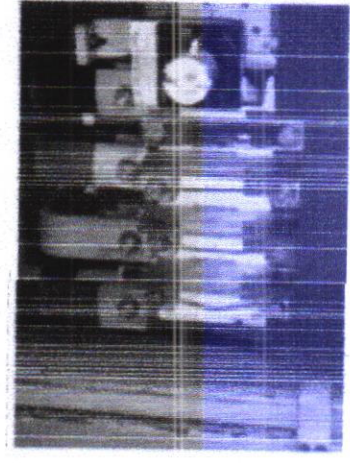
6. Location: MSB 1/SB4 Laundry

Measurements	Max	46.8	°C
Bx1			
Parameters			
Emissivity		0.98	
Ref. temp.		40 °C

Replace the temporary fuse with a permanent fuse of the appropriate rating to are done on 12/7/2025

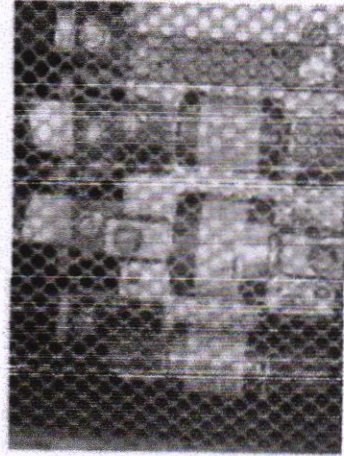
7. Location: MSB 1/SB6	Inference & suggestion	Compliance status

Measurements		°C
Bx1	11004	53.3
Parameters		
Emissivity		0.08
Ref. temp		40 °C

<p>All bolting are properly tightened and the fuse is securely fixed. 15/7/2025</p>

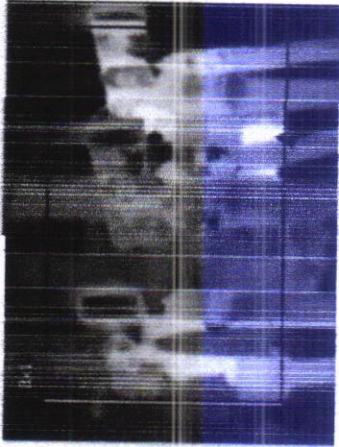
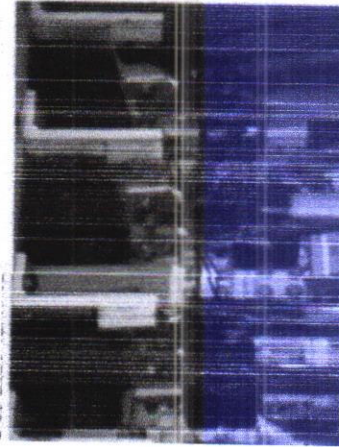
8. Location: Chavara Block / 500kVA incomer	Inference & suggestion	Compliance status

<table border="1" data-bbox="750 1383 925 1905"><thead><tr><th colspan="2">Measurements</th><th>°C</th></tr></thead><tbody><tr><td>Bx1</td><td>Max</td><td>53.3</td></tr></tbody></table> <table border="1" data-bbox="829 1746 925 1905"><thead><tr><th colspan="2">Parameters</th></tr></thead><tbody><tr><td>Emissivity</td><td>0.98</td></tr><tr><td>Ref. temp.</td><td>40 °C</td></tr></tbody></table>	Measurements		°C	Bx1	Max	53.3	Parameters		Emissivity	0.98	Ref. temp.	40 °C	Re crimping done 12/7/2025	
Measurements		°C												
Bx1	Max	53.3												
Parameters														
Emissivity	0.98													
Ref. temp.	40 °C

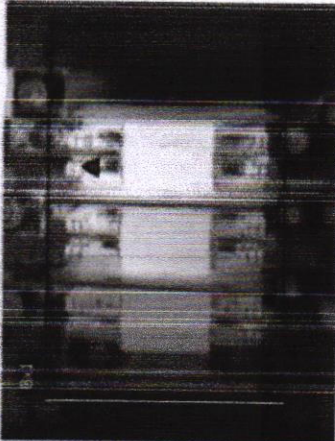
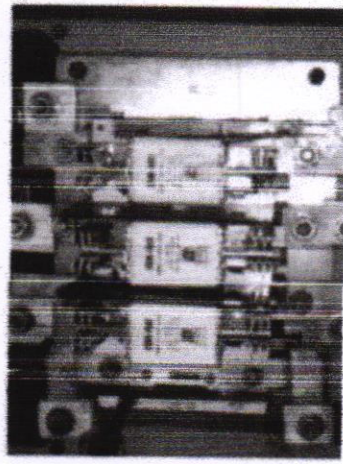
<p>9. Location: MSB 1/SB-6/SSB -6E near new OP</p>

Measurements		°C
Bx1	Max	48.5
Parameters		
Emissivity		0.88
Ref. temp.		40 °C

<p>Inference & suggestion</p> <p>Fuse is securely fixed</p>	<p>Compliance status</p> <p>16/7/2025</p>
---	---	--	--	--

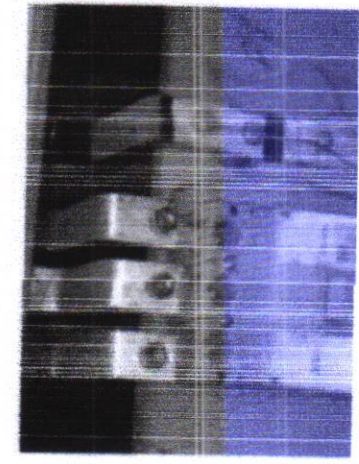
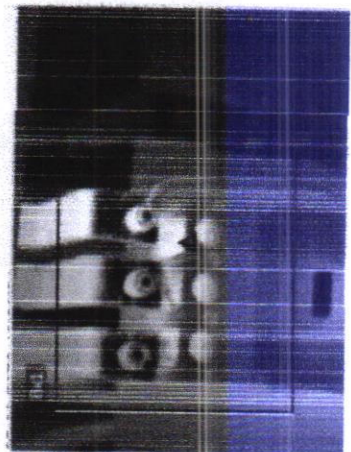
10. Location: MSB-1/SB-6 Incomer

Measurements	Max	46.8	°C
Bx1			
Parameters			
Emissivity		0.08	
Ref. temp.		40 °C

Inference & suggestion	Compliance status
<p>Checked all terminations, ensure that all bolts are properly tightened, 13/7/2025</p>

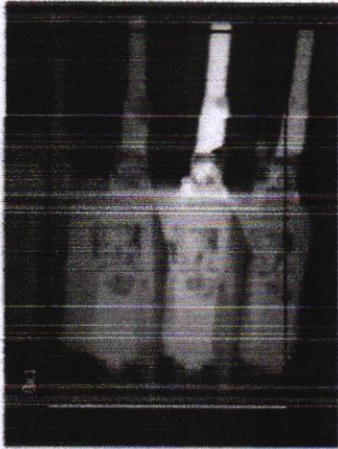
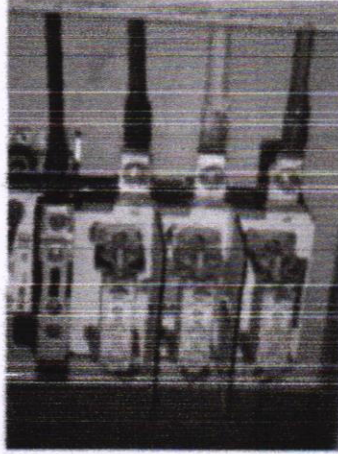
11. Location: MSB-1/SB4/Spares WTP

Measurements	Min	Max	°C
Bx1		47.3	
Parameters			
Emissivity	0.98		
Ref. temp.	40 °C

Re crimp and re terminate the Y-phase cable to address overheating issues
9/7/2025

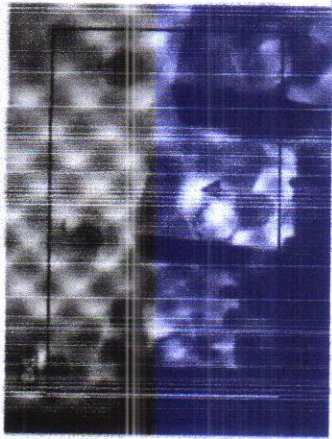
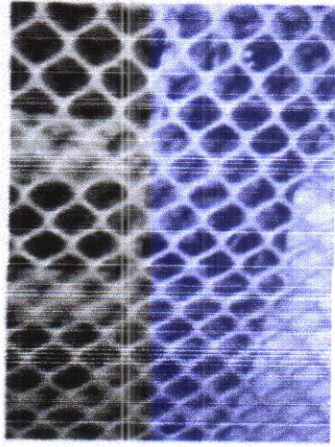
12. Location: MSB-1 SB-3 Incomer

Measurements	Max	49.6	°C
Bx1			
Parameters			
Emissivity		0.98	
Ref. Temp.		40 °C

Compliance status	Inference & suggestion	
	<p>Checked all terminations, ensure that all bolts are properly tightened 02/7/2025</p>

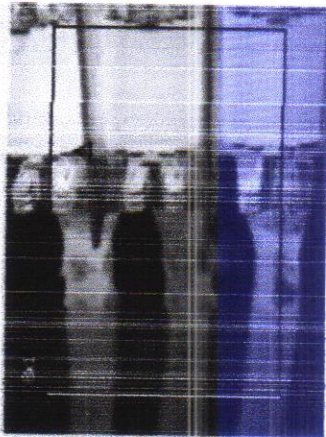
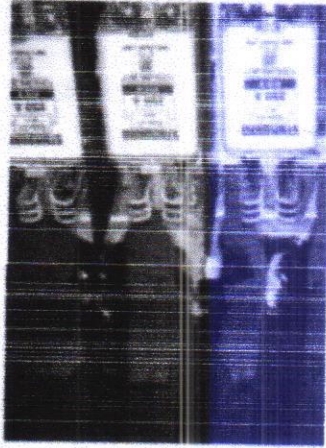
14. Location: MSB 1/SB 2I incomer

Measurements		°C
Bx1	Mixr	53.6
Parameters		
Emissivity		0.98
Ref. temp.		40 °C

Compliance status	Inference & suggestion	
	<p>All bolting are properly tightened, the fuse is securely fixed, 30/6/2025</p>

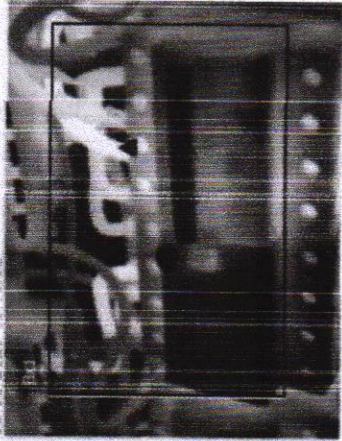
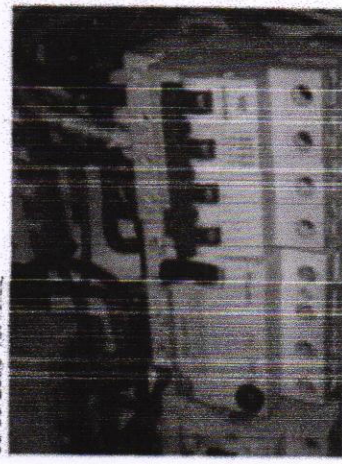
15. Location: Wall DB -- blood bank

Inference & suggestion	Compliance status								
	<p>Measurements</p> <table border="1"> <tr> <td>Bx1</td> <td>Max</td> <td>43.5</td> <td>°C</td> </tr> </table> <p>Parameters</p> <table border="1"> <tr> <td>Emissivity</td> <td>0.98</td> </tr> <tr> <td>Ref. temp.</td> <td>40 °C</td> </tr> </table>	Bx1	Max	43.5	°C	Emissivity	0.98	Ref. temp.	40 °C		<p>Loads are properly distributed among the Phases, 12/7/2025</p>	
Bx1	Max	43.5	°C									
Emissivity	0.98											
Ref. temp.	40 °C

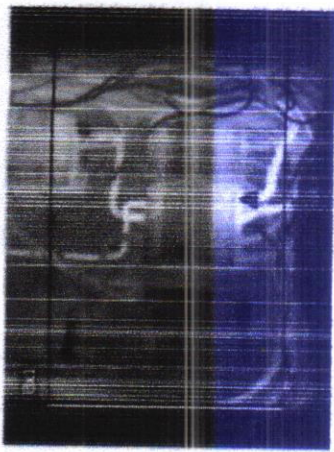
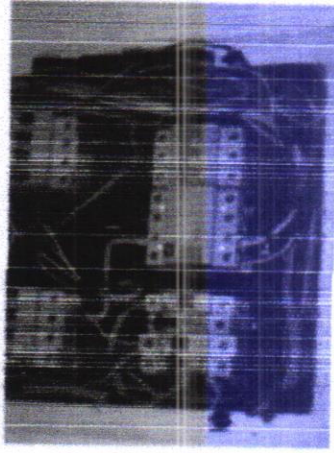
16. Location: Wall DB - Ward 18

Measurements	°C	
Bx1	Mix	74.7
Parameters		
Emissivity	0.68	
Ref. temp.	40 °C

Compliance status	Inference & suggestion	
	<p>The B-phase cable termination is secure, all terminations are properly tightened, 13/7/2025</p>

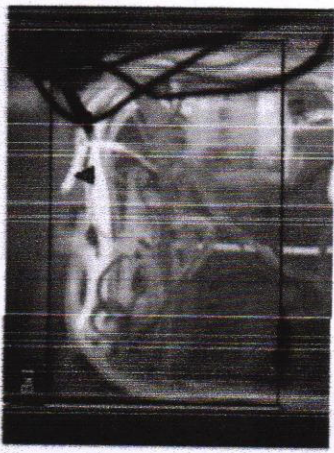
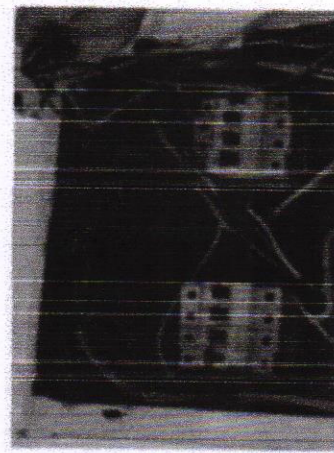
17. Location: Wall DB - Ward 18	Inference & suggestion	Compliance status

Measurements	°C	
Bx1	Max	50.9
Parameters		
Emissivity	0.98	
Ref. Temp.	40 °C

<p>The cable joints are avoided 11/7/2025</p>

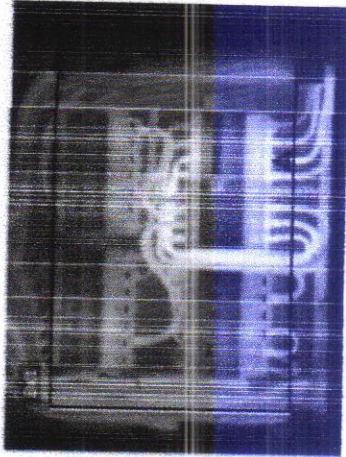
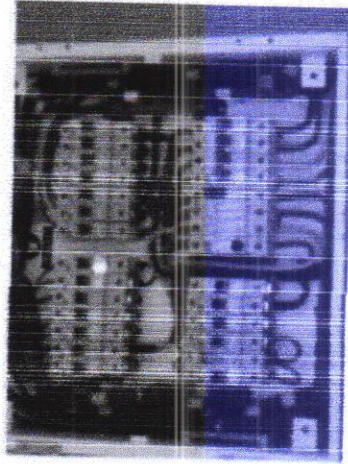
18. Location: Gastro Dept OP wall DB

Measurements		°C
Bx1	Max	43.5
Parameters		
Emissivity		0.98
Ref. temp.		40 °C

All cable terminations are secure.
29/6/2025

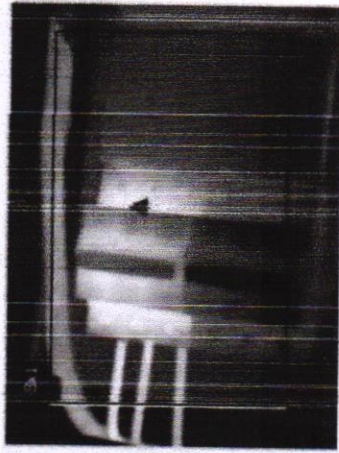
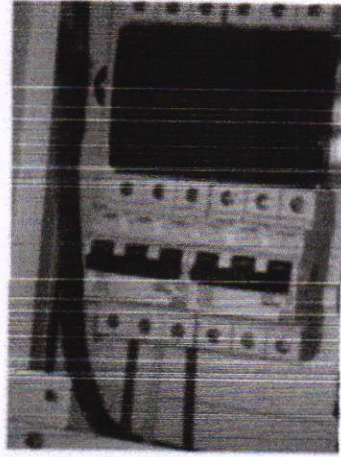
19. Location: Ward 20, Gastro VDB

Measurements	Max	48.1	°C
Bx1			
Parameters			
Emissivity		0.98	
Ref. temp.		40 °C

All cable terminations are properly tightened
22/6/2025
