ELECTRICAL SAFETY AUDIT REPORT

(Post Implementation)

**AMALA INSTITUTE OF MEDICAL
SCIENCES**

July 2025

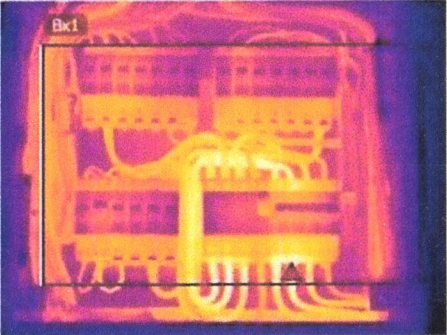
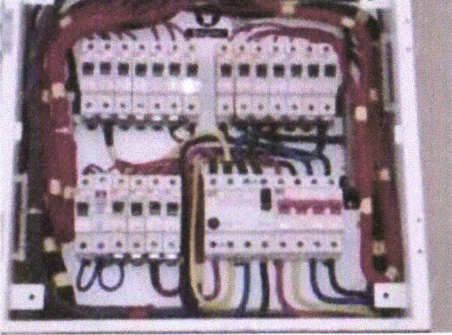
18. Location: Gastro Dept OP wall DB	Inference & suggestion	Compliance status															
<div style="display: flex; justify-content: space-around;">

<table><tr> <td colspan="2">Measurements</td> <td style="text-align: right;">°C</td> </tr></table>

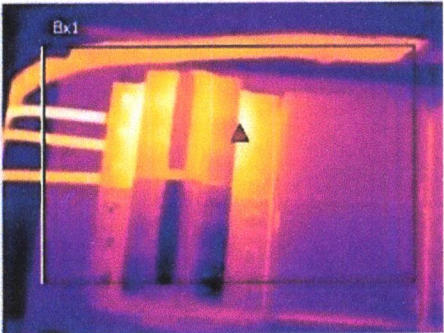
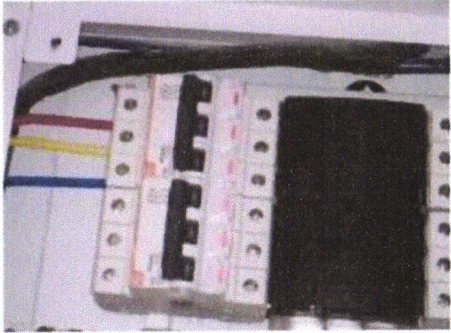
19. Location: Ward 20, Gastro VDB	Inference & suggestion	Compliance status												
<div style="display: flex; justify-content: space-around;">

</div> <table border="1" style="width: 100%; margin-top: 10px;"> <thead> <tr> <th colspan="2">Measurements</th> <th style="text-align: right;">°C</th> </tr> </thead> <tbody> <tr> <td>Bx1</td> <td style="text-align: center;">Max</td> <td style="text-align: center;">48.1</td> </tr> </tbody> </table> <table border="1" style="width: 100%;"> <thead> <tr> <th colspan="2">Parameters</th> </tr> </thead> <tbody> <tr> <td>Emissivity</td> <td style="text-align: center;">0.98</td> </tr> <tr> <td>Ref. temp.</td> <td style="text-align: center;">40 °C</td> </tr> </tbody> </table>	Measurements		°C	Bx1	Max	48.1	Parameters		Emissivity	0.98	Ref. temp.	40 °C	<p>All cable terminations are properly tightened 22/6/2025</p>	
Measurements		°C												
Bx1	Max	48.1

Parameters														
Emissivity	0.98													
Ref. temp.	40 °C

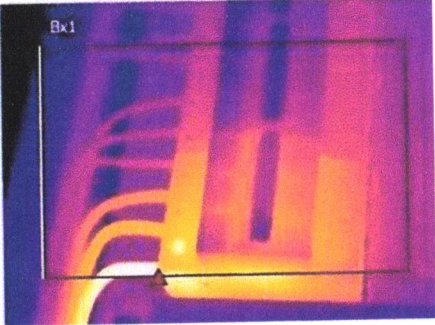
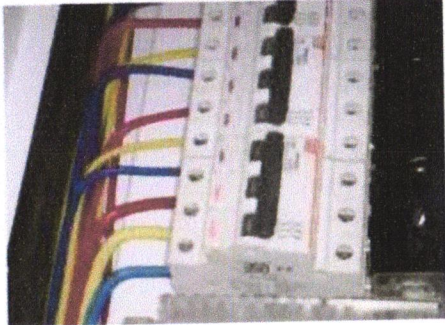
20. Location: Pneumatic operations room	Inference & suggestion	Compliance status															
<div style="display: flex; justify-content: space-around;">

<table><tr> <td colspan="2">Measurements</td> <td style="text-align: right;">°C</td> </tr></table>
