Electrical Safety Audit
Report

ELECTRICAL SAFETY AUDIT REPORT

(Post Implementation)

**AMALA INSTITUTE OF MEDICAL
SCIENCES**

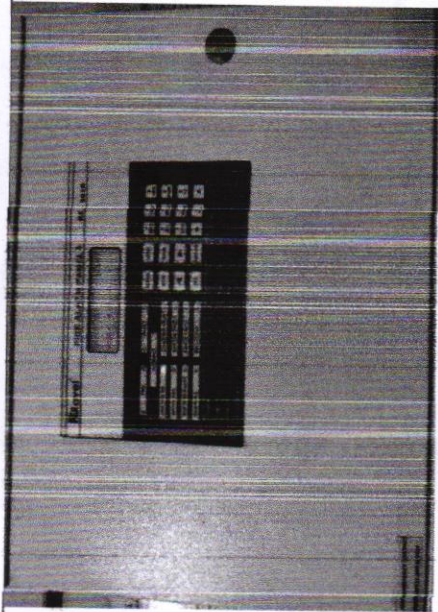
<p>Ensure that all fire exits are clearly marked as per NBC Part 4 - Fire and Life Safety, kept unlocked during occupancy, and kept free from obstructions to maintain clear evacuation paths</p>	<p>Implemented on 15/7/2025</p>
<p>13</p>	<p>Medium</p> <p>One of the fire alarm panels was found to be silenced due to a faulty alarm trigger</p>	<p>Chavara block - Ground floor</p>

<p>The fault in the detector has been addressed, and the fire alarm panel is now healthy and no longer silenced</p>	<p>Implemented on 11/07/25</p>
